**Paper No.
11851**

Failure Analyses: In Retrospect

Nurul Asni Mohamed

Malaysian Refining Company Sdn Bhd (MRCBSB)

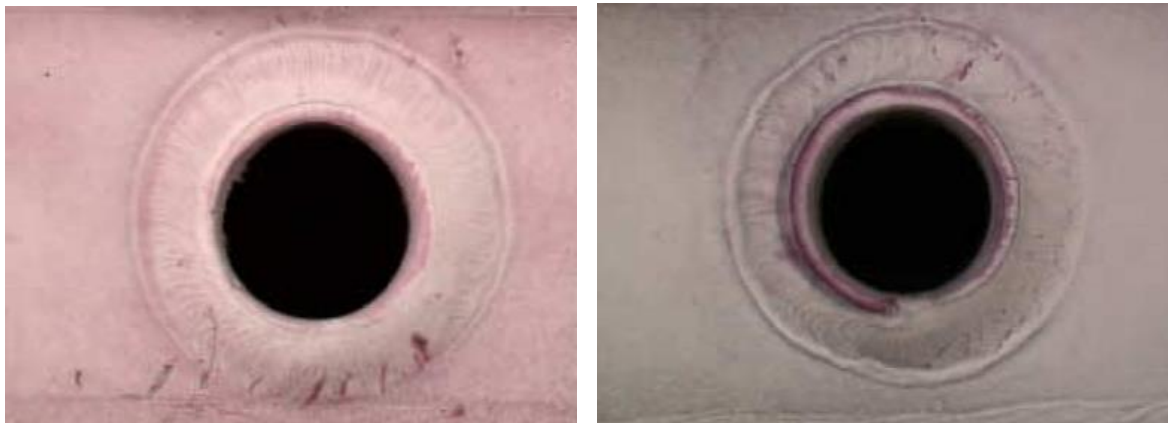
During the commissioning of the DSS 2205 in 2002, leak of one air-fin cooler bundle was detected along with the smell of H_2S . Snoop or bubble leak test was performed and leaks were observed to have occurred at various tube to tube sheet welds of all four REAC tube bundles. A detailed root cause failure analysis was conducted with tube samples sent to a third party failure analysis laboratory in the UK. The results revealed that the tube to tubesheet weldments failed due to sulphide stress cracking (SSC) which occurred during the introduction of H_2S containing hydrocarbon gas along with the presence of water.

Dye Penetrant tests were carried out on 237 welds chosen randomly from the four REACs tube to tubesheet welds. 64% were found to exhibit cracks from examples seen from Figure 2. Scanning Electron Microscopy of the fracture surfaces revealed straight angular cracks with no evidence of oxidation. Fracture surfaces indicated mainly brittle fracture regime, with a number of interconnected local defects forming the final fracture surface. See Figure 3 for transgranular cracking observed. No link was found between cracking propensity and hardness as only one sample had hardness value recorded slightly above the specified limit of 310 HV.

Ferrite checks using image analysis found local ferrite volume fraction to be in the range of 82–86% at areas where cracks have been found although ferrite count at other areas averages between 45 – 65%. The fabrication specification required ferrite count to be below 60%. The high ferrite volume fractions were observed mainly at the locations of welds start/stop, considering that it was a two-pass weldment. Hot cracking from fabrication was excluded due to the fact that cracking was primarily transgranular, with no evidence of low melting films at the grain boundaries. At the point of the investigation conclusion, the principal causes of the observed failures were the initiation of Sulphide Stress Cracking at the weld surface, due to the limited tolerance of the localised ferrite content of the tube to tubesheet weldments of DSS 2205 to the process environment.

Figure 2 Dye penetrant results on the DSS 2205 tube to tubesheet welds

Repair was carried out via enhancement of the weldment procedure and testing of the mock up welds. Stringent checks were carried out during re-fabrication to ensure the application of minimum preheat temperature of 10⁰C, maximum interpass temperature not exceeding 150⁰C and that the start/stop of the weldments for the second weldment pass do not end at the same point.

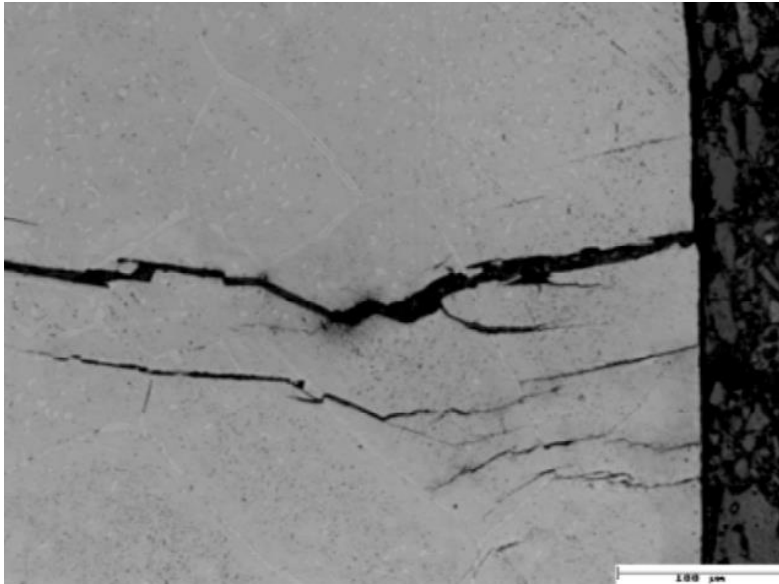
Figure 3 Transgranular cracking (cracking through the grains) from SEM

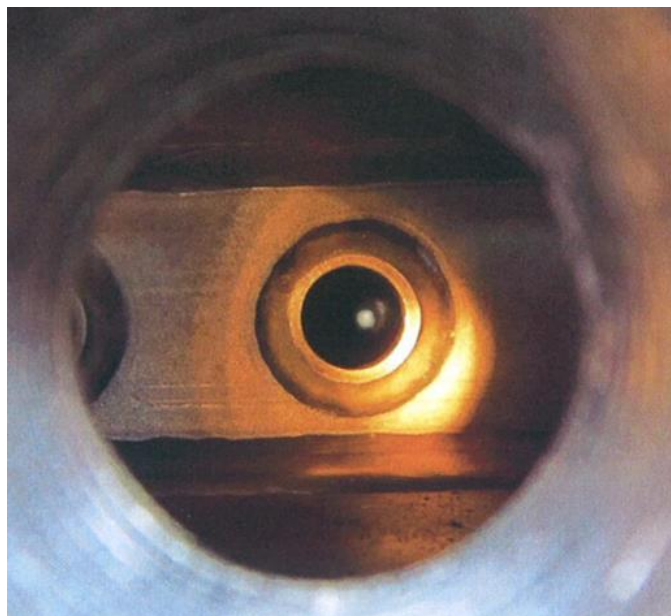
Revisiting this case study, the REACs have been in service since 2003 installation with no other leak incidences reported. The latest tube to tubesheet weldments can be observed from the 2015 turnaround inspection in Figure 4. Corrosion monitoring involves the monitoring of ammonium bisulphide concentration via trending of sulphur and nitrogen in the feed to the hydrocracker unit. The ammonium bisulphide limit is set to less than 8 wt% for DSS 2205 and considering the outlet piping has also been upgraded to Alloy 825. Continuous water wash is applied to dissolve the ammonium bisulphide salts and the amount of water injected is also one of the Integrity Operating Window (IOW) parameter that is closely monitored. API RP 932-B provides an excellent reference for design and corrosion control for REAC system.

Figure 4 Latest turnaround photo of REAC tube to tubesheet weld in 2015

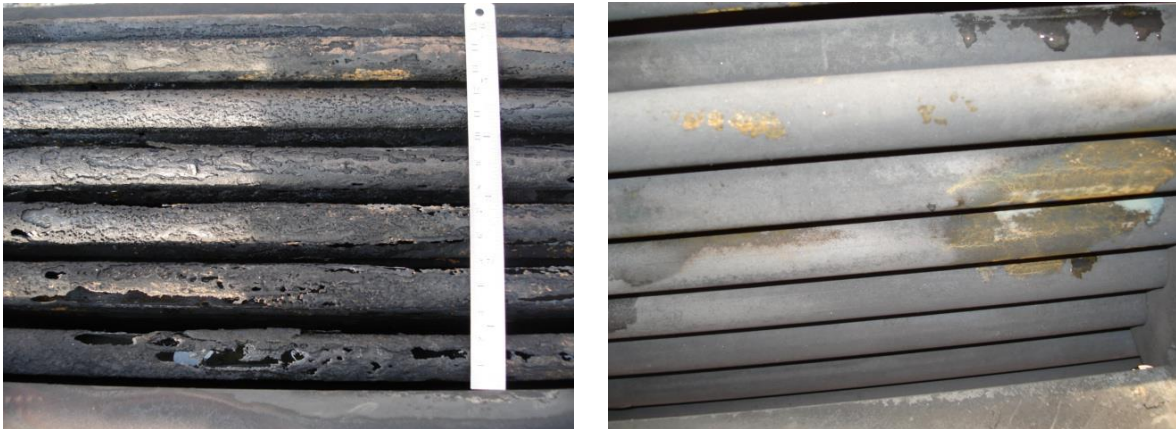
Typical inspection findings for the carbon steel tubes as shown in Figure 6, would record that the upper and bend portions revealed relatively severe corrosion wastage around the circumference while the lower portion appeared relatively unaffected with a uniform thin layer of blackish scale/deposits. Cracks were also observed in the upper portion of the tubes. The internal surfaces of the tubes were generally satisfactory, with no significant signs of corrosion. Analyses of the corroded surface did not reveal much in terms of contaminants, probably because leaks from tubeside containing steam could probably have washed away any evidence. Therefore, sour water samples were taken for analyses and test results noted presence of cyanide in the amount of 2.3 mg/L and chlorides 24 mg/L.

Further investigations revealed that the top row tubes that underwent aggressive corrosion because they were exposed to wet/dry condition from the presence of vapour space in the reboiler. Various tube metallurgies corroded due to the condition known as departure from nucleate boiling where chlorides present in the sour water at lower temperature could be manageable but becomes highly concentrated upon boiling at the tubeskin surface where Medium Pressure steam is the fluid, operating at 181°C. The concentrated chlorides also led to Chloride Stress Corrosion Cracking (CLSCC) of SS 316 and DSS 2205. The non-aged damage from CLSCC made it more challenging with the use of stainless steels.

For the killed carbon steel tube thickness of 3.04 mm, the corrosion rate varied between 2.4 to 3.7 mm/y. Previous checking of tube bundle condition at 6th, 7th or 8th month in service did not exhibit any leaks. Therefore, a decision was made to replace the carbon steel bundles on time-based. It would be highly challenging to find a material that will meet the service requirement as well as providing a low Return on Investment (ROI).

Figure 6 Sour water stripper reboiler (carbon steel) top row tubes (left) and bottom row tubes (right)

In resolving this corrosion issue, among the main mitigation involves changing the reboiler design from a horizontal type to a vertical thermosyphon. This will require substantial work as it would involve upgrading of the stripper column internals along with the interconnecting piping. Fast-forward to 2017, a project is currently underway to revisit this redesign initiative. A more recent refinery has already incorporated this experience and designed its sour water stripper reboiler as a vertical thermosyphon. It will be commissioned in 2019.

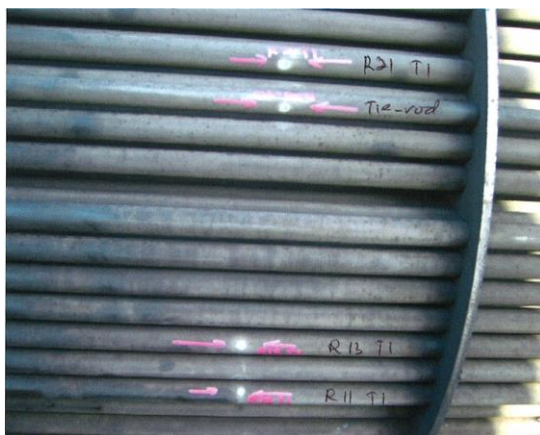
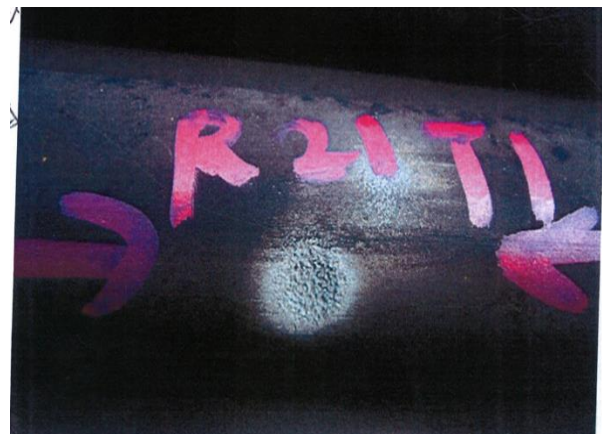
The Lubricant plant was commissioned in 2009. In 2010, during the warranty shutdown, the VDU Feed/BPA exchanger external tubes were discovered to exhibit localised crater-like corrosion attack (refer Figure 8). The nominal tube thickness was 2.03 mm. There was no leak reported of this exchanger. However, a maximum wall loss of 70% was recorded from eddy current testing data. This led to a calculated corrosion rate of 1.4 mm/y, assuming a constant wall loss over the service period of about one year. Opportunity inspection in 2012 and turnaround in 2015 did not find the corrosion to be aggravated.

The most probable damage mechanism that can be drawn from this analysis is naphthenic acid corrosion despite the lower TAN value. Corrosion due to chlorides has been ruled out due to the high temperature of the BPA which falls within the naphthenic acid corrosion range of 220 to 400°C. The cause of the micro-cracks remains to be determined. Analysis of chlorides in the BPA stream has been included in order to understand the possible effects of chloride presence to the tube external. No other equipment in within this corrosion group has exhibited such localised attack.

Figure 8 Several localised corrosion attack observed on Feed/BPA exchanger tube external as shown in the left picture and close up shown in the right picture.

IOW monitoring of TAN is still being implemented (refer Figure 10). Any future upgrade of metallurgy to SS 317 for mitigation of naphthenic acid corrosion depends on the findings during the next planned inspection in 2019.

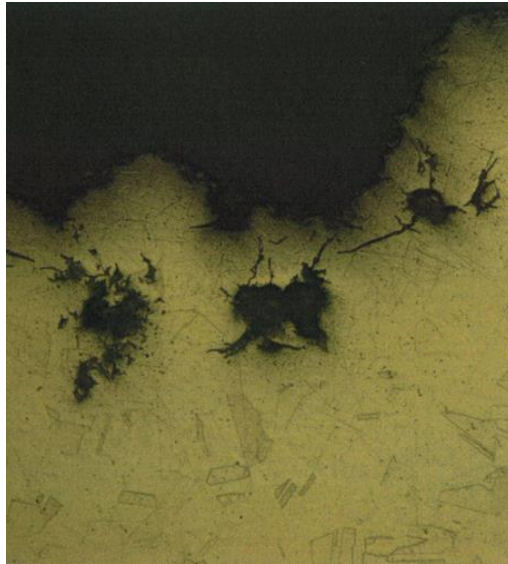
Tube samples were retrieved and sent for analysis. Results of the crater area did not reveal any contaminants or expected corrosive species like chlorides. Micrograph of the crater area is shown in Figure 9. Micro-pits were observed with branching transgranular micro-cracks. The BPA service is expected to contain some naphthenic acid species and Total Acid Number (TAN) limit has been set to less than 1.5 mgKOH/g. The monitoring of TAN as an IOW parameter has always been below the limit. Another point that was highlighted from the failure analysis was that the molybdenum content at area of localised corrosion was 2.16 wt%. This is considered to be within the acceptable limit for SS 316L where molybdenum content is specified between 2-3 wt%. Nevertheless, the amount of molybdenum required for mitigation against naphthenic acid corrosion is 2.5 wt%.

Figure 9 Micrographs of crater showing micro-pits with branching of transgranular cracks (magnification x200)
