**Paper No.
11851**

Failure Analyses: In Retrospect

Nurul Asni Mohamed

Malaysian Refining Company Sdn Bhd (MRCBSB)

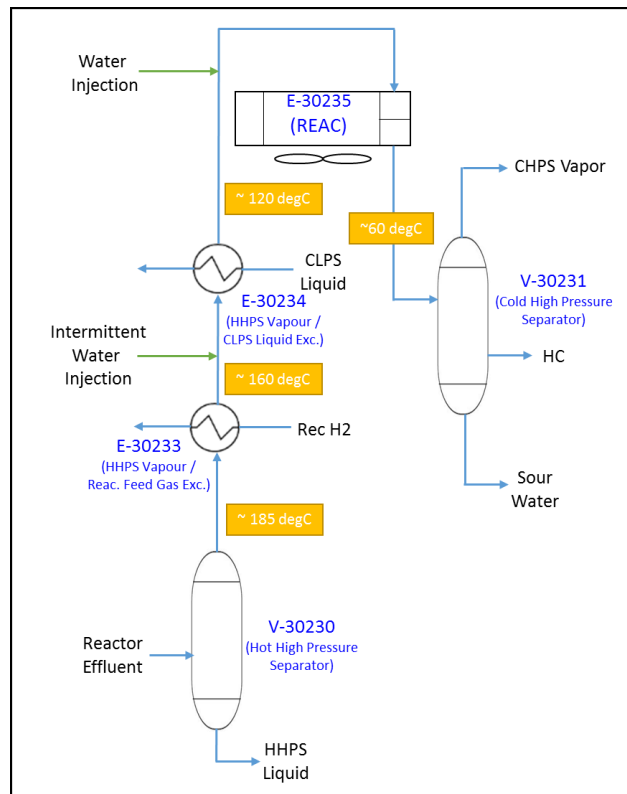
Figure 1 Simplified process flow diagram of the REAC system

The hydrocracker unit receives feed from vacuum gas oil from the crude unit and uses hydrogen and catalyst under high pressure and high temperature conditions to produce naphtha, kerosene and diesel. The byproducts of this reaction are ammonia (NH_3) and hydrogen sulphide (H_2S) which are unwanted. Ammonia and hydrogen sulphide combines to form ammonium bisulphide (NH_4HS) salts upon cooling in the reactor effluent air-fin cooler (REAC). Continuous water wash is employed to ensure that fouling does not occur in the REAC tubes. Care must be taken to ensure adequate amount of water is injected to dissolve the salts. Insufficient water can lead to aggressive ammonium bisulphide corrosion as the salts are hygroscopic. Excessive water can lead to erosion corrosion of tube ends as well as elbows of the REAC outlet piping. Figure 1 depicts a simplified process diagram of the hydrocracker REAC system.

The hydrocracker reactor effluent air-fin cooler tubes were upgraded from carbon steel to duplex stainless steel type UNS31803 (22% Cr, 5.5% Ni) or commonly known as DSS 2205. This is to mitigate the effects from ammonium bisulphide corrosion. The REACs are designed for a fluid velocity of between 4.3 m/s and 6.0 m/s at a pressure of 186.4 kg/cm², an inlet temperature of 192°C and outlet temperature of 60°C.

During the commissioning of the DSS 2205 in 2002, leak of one air-fin cooler bundle was detected along with the smell of H_2S . Snoop or bubble leak test was performed and leaks were observed to have occurred at various tube to tube sheet welds of all four REAC tube bundles. A detailed root cause failure analysis was conducted with tube samples sent to a third party failure analysis laboratory in the UK. The results revealed that the tube to tubesheet weldments failed due to sulphide stress cracking (SSC) which occurred during the introduction of H_2S containing hydrocarbon gas along with the presence of water.

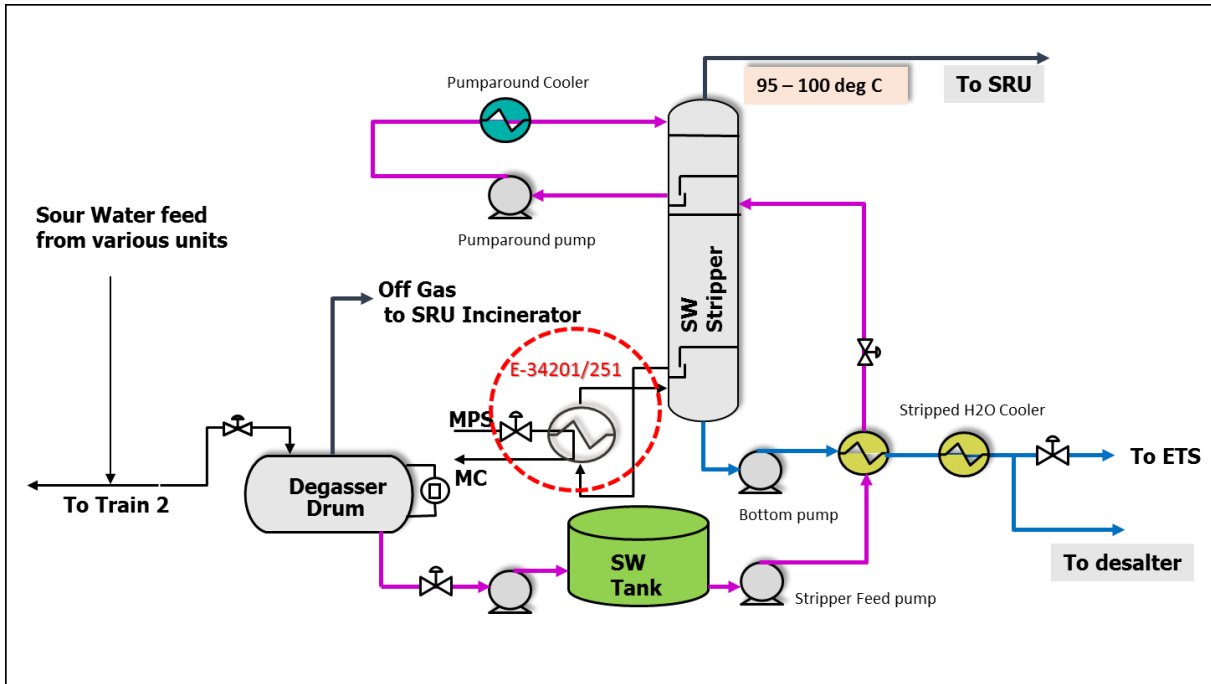
Figure 5 Simplified diagram of the sour water stripper column and sour water stripper reboiler

The sour water treating unit treats the sour water streams produced by processes within the sour train refinery. Sour water contains dissolved NH₃, H₂S and phenols. These contaminants are removed from the sour water in two trains where each train incorporates a single stripping column. The heating in the column is provided by the sour water stripper reboiler. The sour gas stream containing the separated contaminants is directed to the sulphur recovery unit. The stripped water is reused within other process units in the refinery, mainly the crude desalter whilst the balance is discharged to the refinery effluent treatment system. Figure 5 shows a simplified diagram of the sour water stripper column and sour water stripper reboiler.

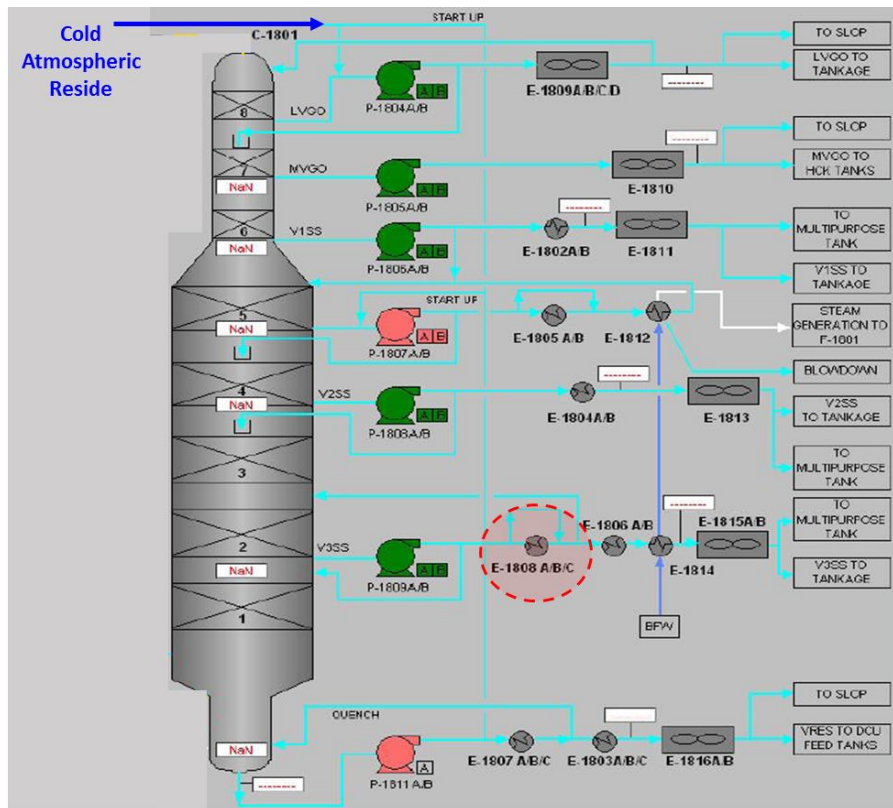
Figure 7 Simplified process flow diagram of Lubricant Plant VDU (showing feed/bottom pumparound exchanger)

The vacuum residue is sent to the delayed coker unit for further processing. Figure 7 represents a simplified process flow diagram of the VDU Feed/Bottom Pumparound (Feed/BPA) exchanger.

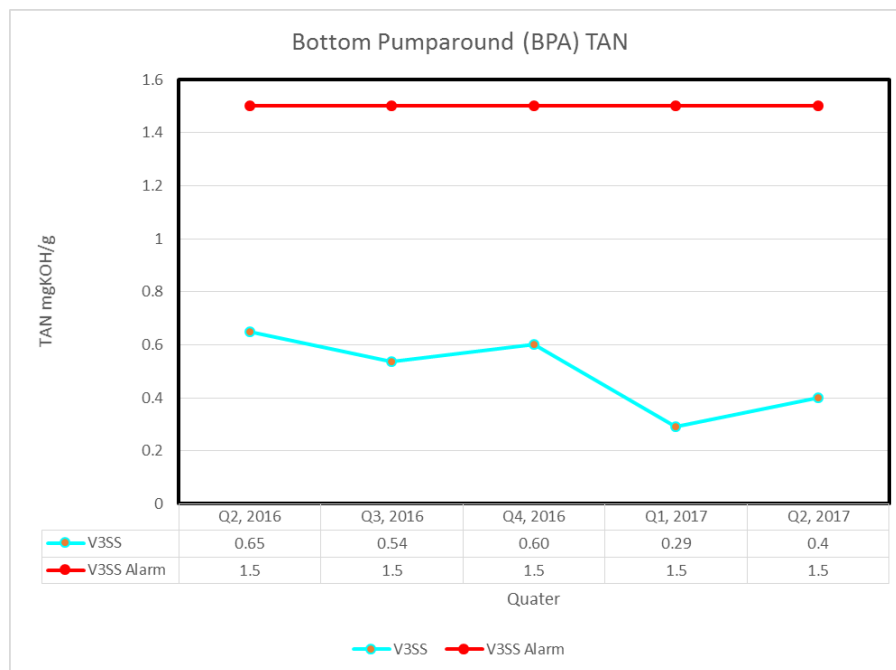
Figure 10 Botttom Pumparound TAN monitoring

IOW monitoring of TAN is still being implemented (refer Figure 10). Any future upgrade of metallurgy to SS 317 for mitigation of naphthenic acid corrosion depends on the findings during the next planned inspection in 2019.

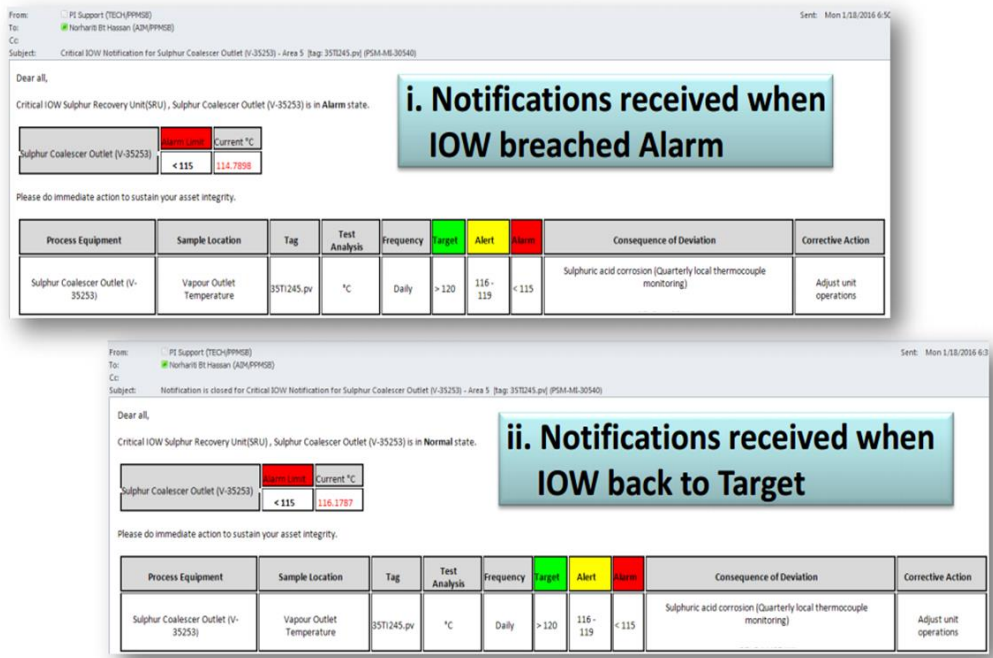
Figure 11 Automatic email notifications during IOW excursions and corrective actions

From the case studies shared, it can be summarised that analyses and conclusions made were correct based on the available information at the point in time. It would be recommended for facilities to revisit past root cause failure analyses findings to make sure that the decisions still stand firm. Sometimes, recently available information from research or others' experiences may shed new light on the issues and could probably bring about a different mitigation. In the effort of going digital and realising the vision to be the Refinery of the Future, some initiatives have been implemented such as the automated warning email to the respective identified parties in the event of IOW parameter excursions as seen in Figure 11. This effort has allowed faster response time to address any negative deviations of IOW limits set.
